# Washington County Schools' Facilities Assessment and Future Capital Planning Analysis

Washington County Board of Education

August 2, 2022

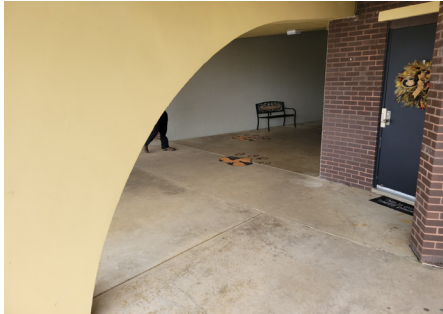
**01** Headroom is not ADA compliant

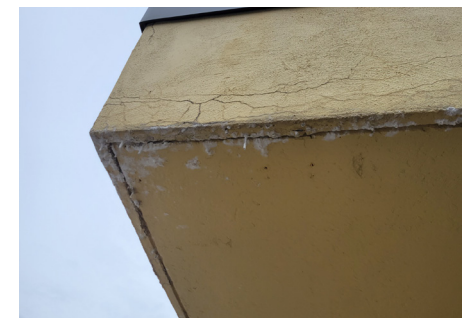
**08** Unknown substance dripping from canopy and staining concrete walks below

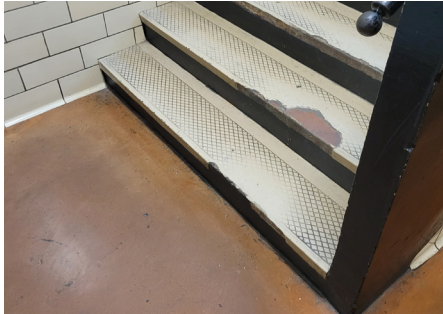
01 Damage and stains are present in some locations

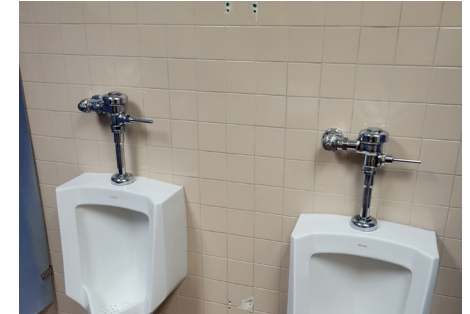
04 Urinal divider missing

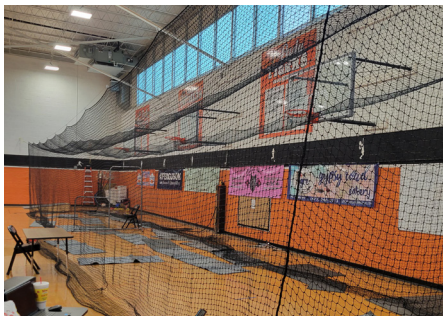
05 Temporary indoor batting cage

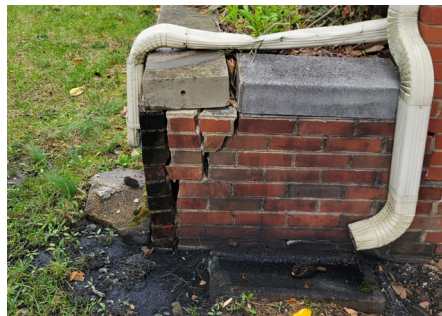
06 Planter wall has failed

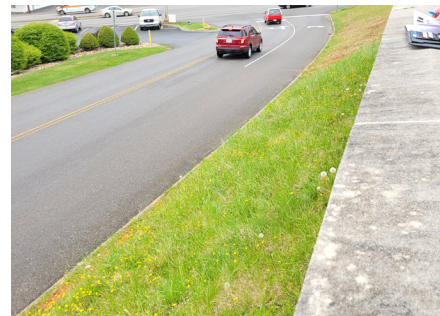
07 Severely limited stand-off distance on western side

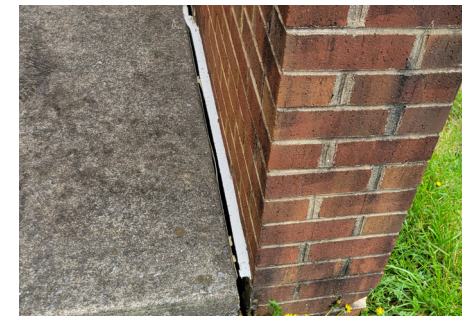
08 Sealant failure exposes joint to freeze-thaw damage

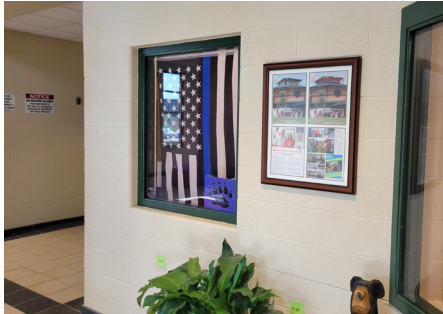
01 SRO Window into lobby is obscured

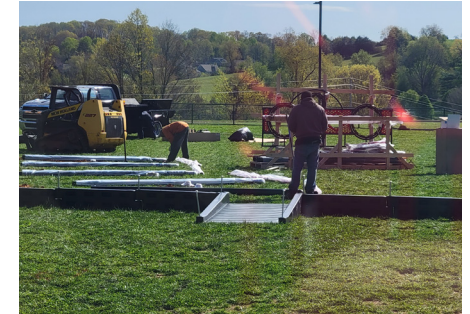
04 New playground already has a ramp installed for accessibility

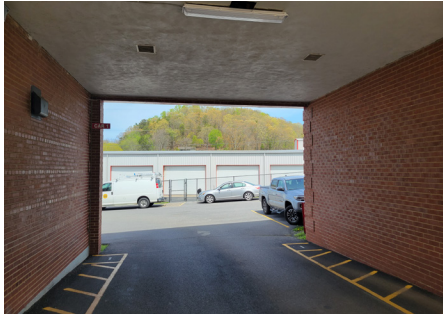
01

Drive-Thru presents a significant security risk

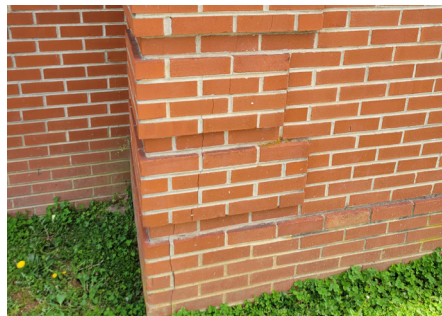
06

- A Lack of brick expansion joints has caused minor and moderate cracking in brick veneer in some locations
- B Some windows are single pane units

Lack of expansion joints has caused minor and moderate cracking

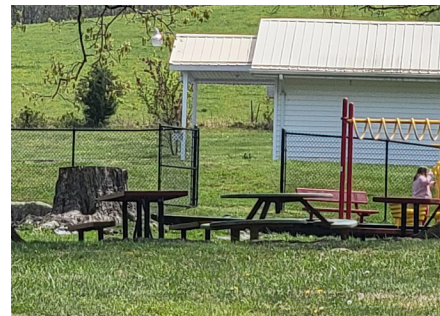
07

Rear gate is unlocked and open

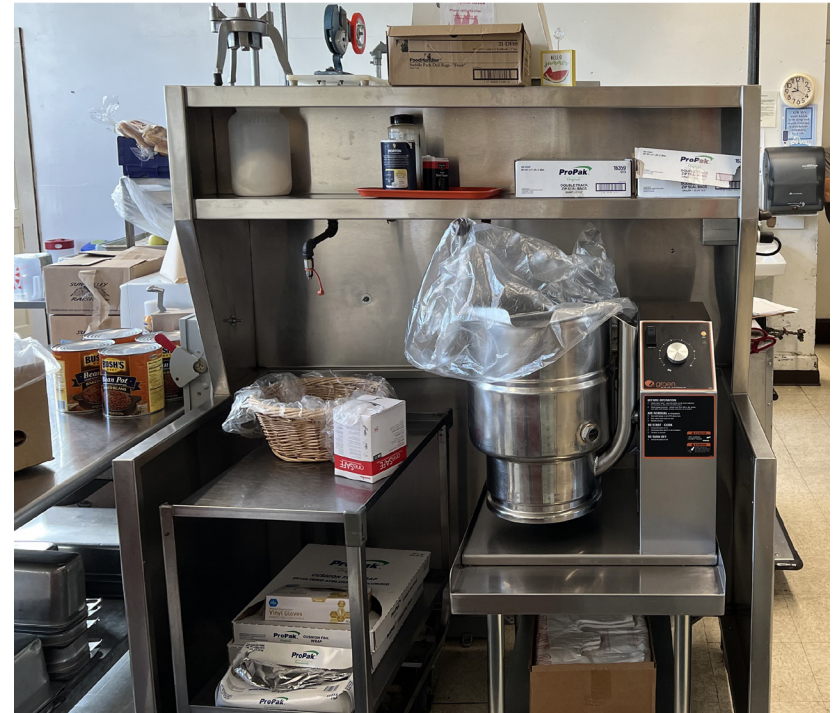
Kitchen has non-code compliant stainless steel back shelf type kitchen hood with make-up air and fire suppression system (See Photo to Right).

- No zoning or comfort issues were reported.
- Building control system is older version of Automated Logic system and should be considered for upgrade as funds become available.
- Locker rooms and janitor's closets do not have exhaust.
- The existing equipment is coming to the end of its expected life and unit replacements due to age should be expected.
- The amount of outside air introduced into the classroom is not up to current codes.
- Overall, the system is very well maintained.
- The existing hood is not large enough to cover the equipment that they have. The hood also doesn't have makeup air.

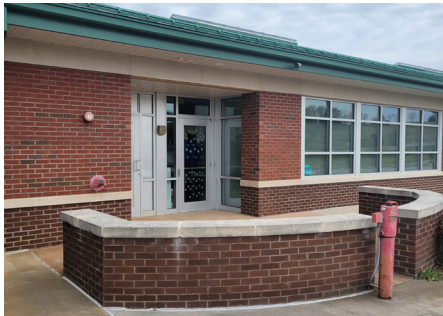
- 01** Efflorescence has developed on several non-cavity masonry walls

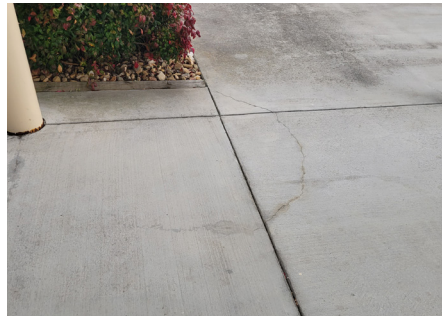
- 02** Minor cracking in the concrete sidewalks

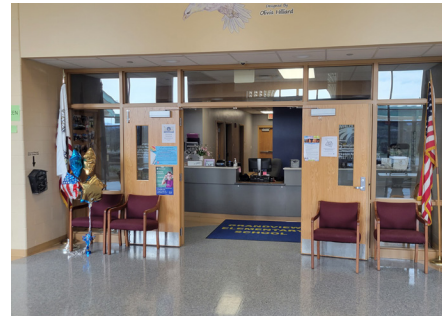
- 03** Large, open lobby with no secure vestibule

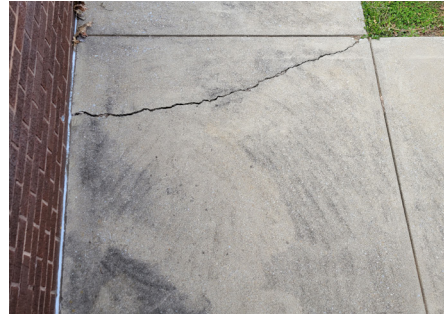
**02** Some cracking has occurred in the sidewalk

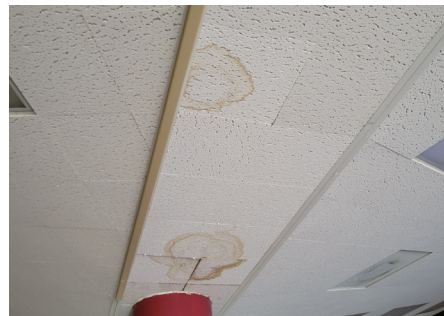
**06** Possible roof leak in media center

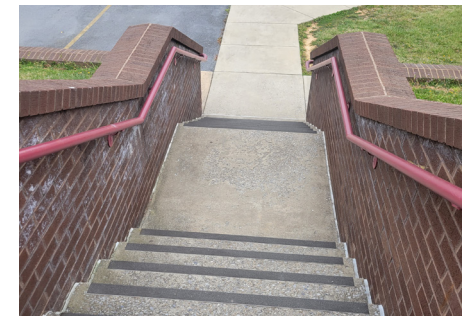
**08** ADA egress requires wheelchair-bound students to go all the way to main entry ramp

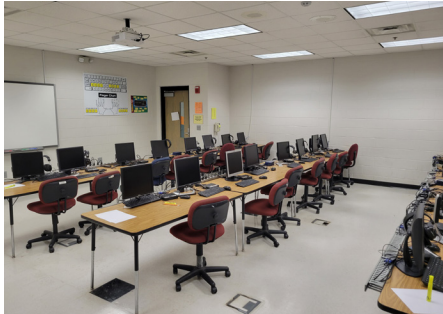
01

Light switch placement is inconvenient in some locations

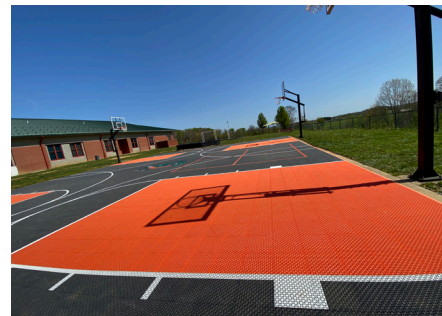
07

Exterior basketball area in good condition

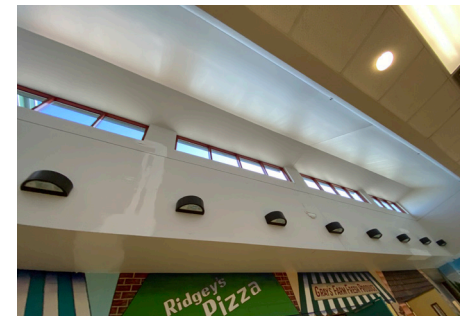
08

Evidence of past leaks from clerestory

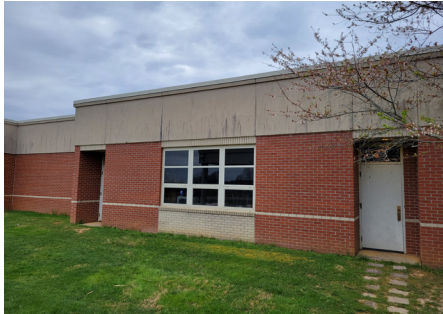
01 EIFS exhibits mild staining

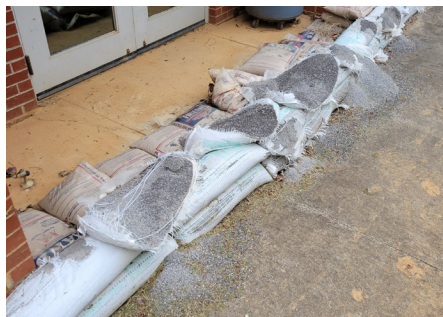
05 Sandbags at cafeteria egress show drainage issue and fire evacuation hazard

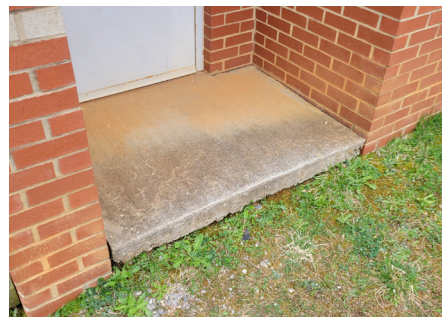
06 Classroom egress landing

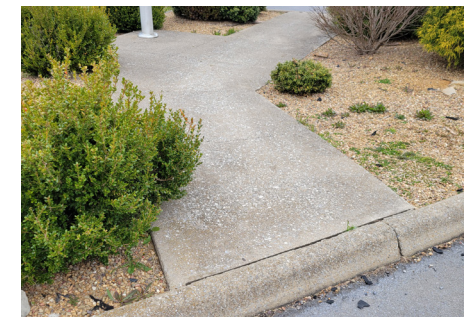
08 ADA parking is not near main entry. Some curb cuts missing from parking lot

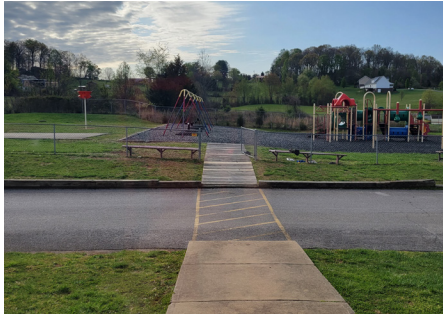
01

Playground and playground access not ADA compliant.

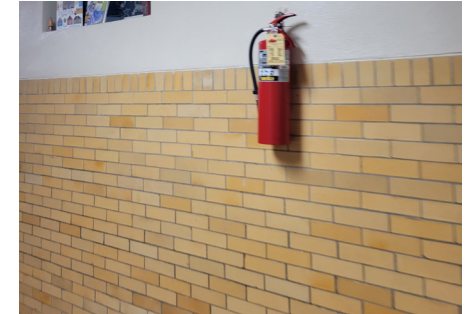
04

Fire extinguisher on bracket is mounted at a non-compliant height.

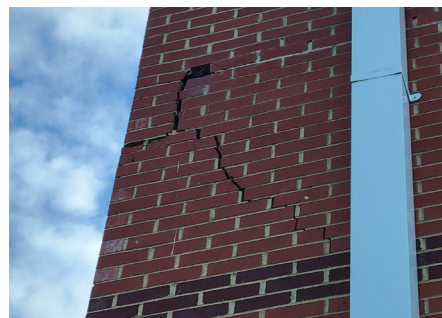
06

Major settlement crack on gymnasium addition

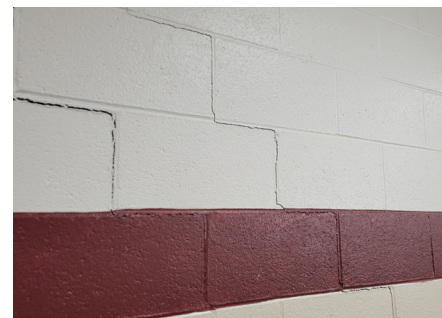
07

Major settlement cracking inside gymnasium addition

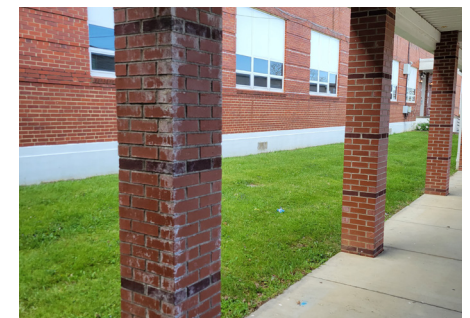
08

Efflorescence on canopy columns

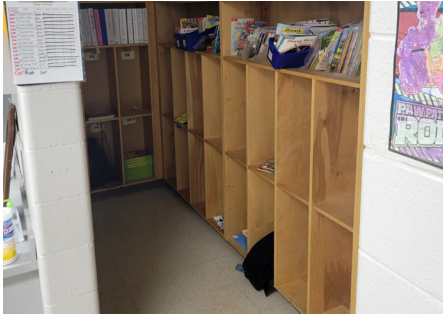
01 Cubby area not ADA compliant

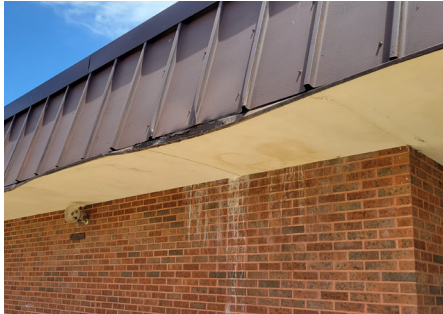
01

Soffit is damaged in several locations around perimeter

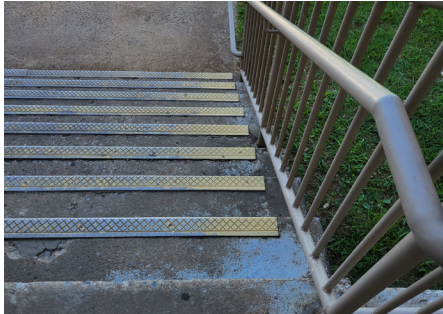
01 Several egress routes are not ADA compliant

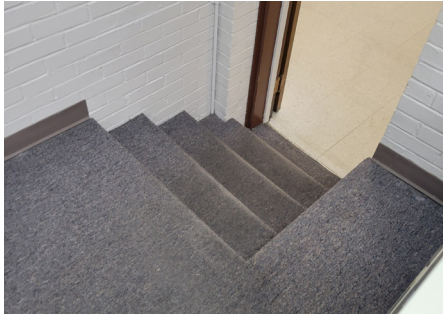
01 "Library" is not ADA accessible from either direction

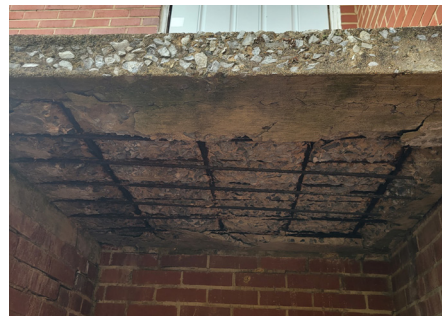
06 Concrete slab is severely damaged; rebar is exposed

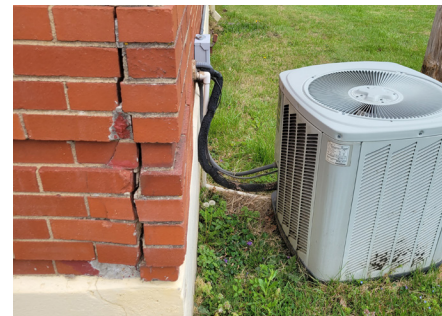
07 No brick expansion joints has caused cracking

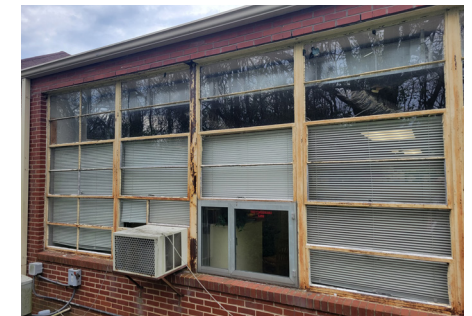
08 Steel windows are discolored/ rusting

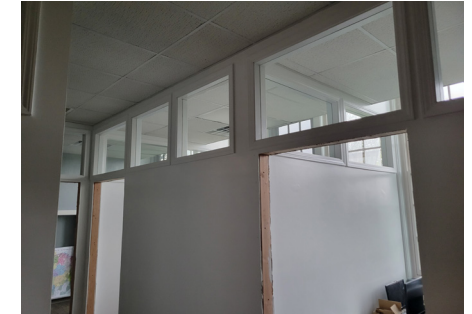
**04** Subdivided classrooms with transform/clerestory windows allow for daylight to reach deep into offices

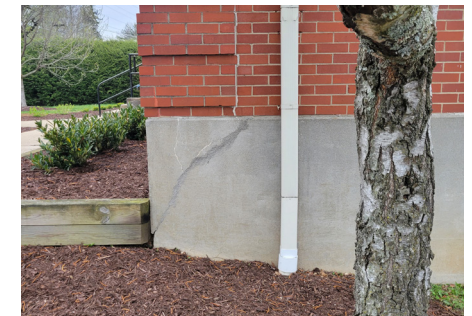
**08** Exterior finish is cracked in several locations - some have been patched

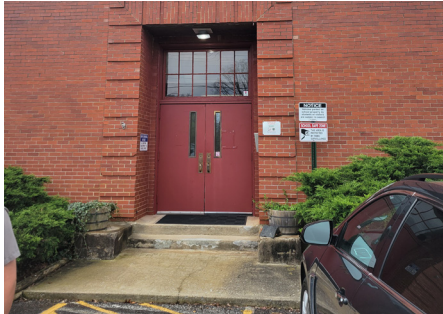
01

Main entry is not ADA compliant

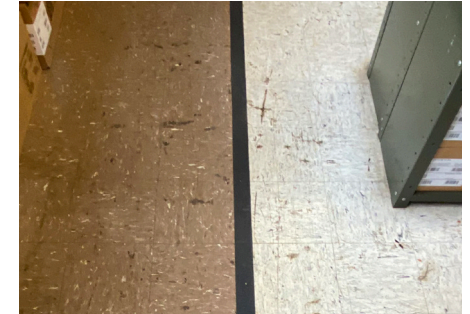
04

Evidence of possible hazardous material in former gym - would require further investigation by appropriate testing agency

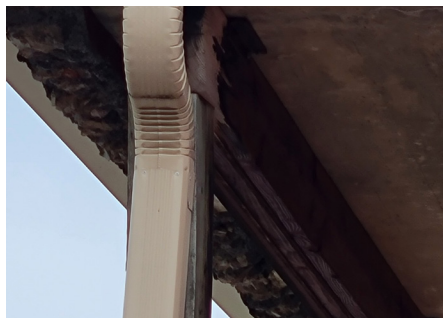
05

Rear canopy appears weathered

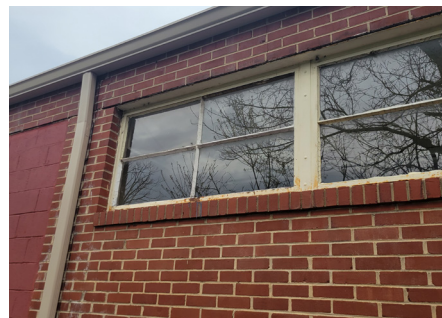
06

Windows in several location have degraded finishes

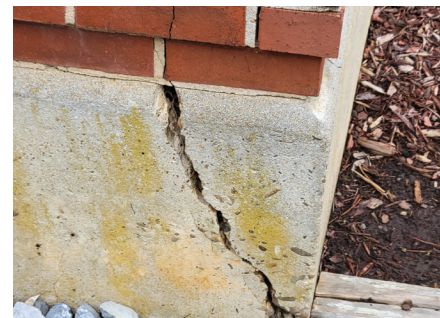
07

Lack of masonry expansion joints has caused significant cracking near main entry

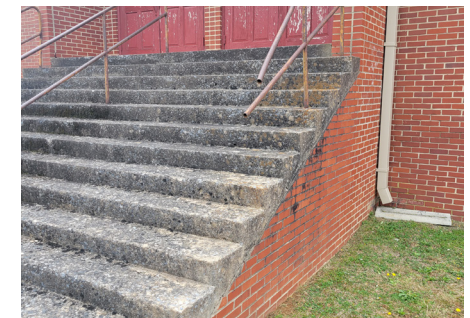
08

Egress route is not ADA accessible
