# Washington County Schools' Facilities Assessment and Future Capital Planning Analysis

Washington County Board of Education

August 2, 2022

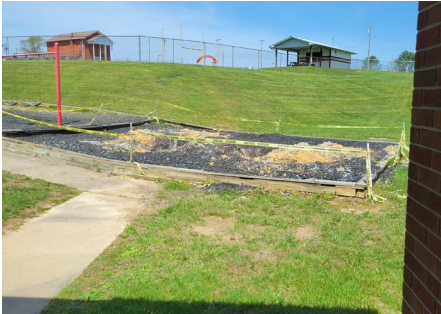
01

Playground under construction

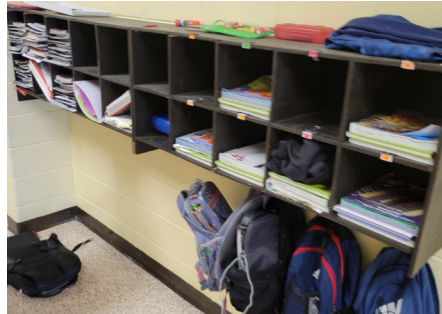
02

Insufficient storage

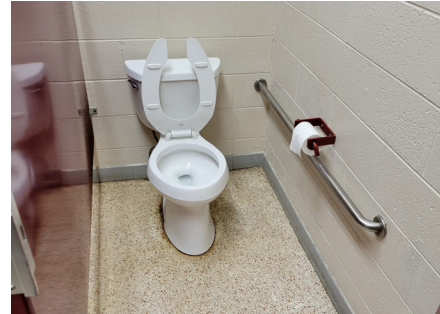
03

Not ADA compliant

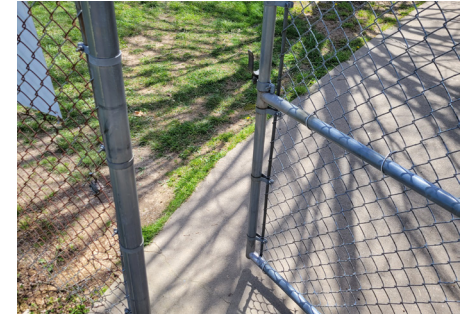
04

Perimeter fencing is unlocked at time of visit

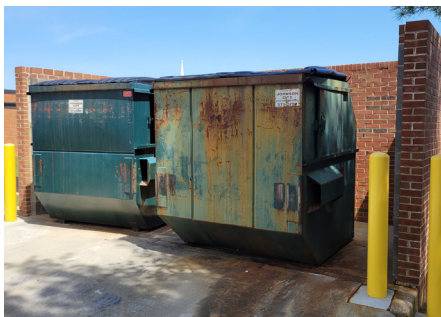
05

Dumpster enclosure unsecure

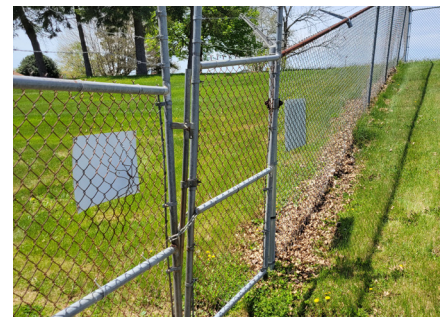
07

Perimeter fencing is locked and barbed wire deters climbing

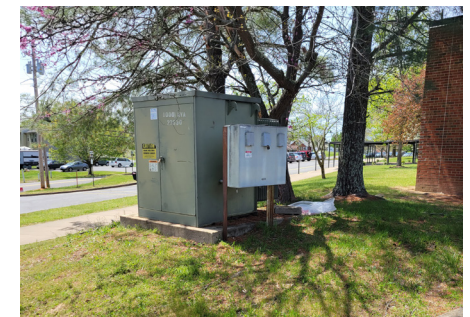
08

Transformer is exposed to public access

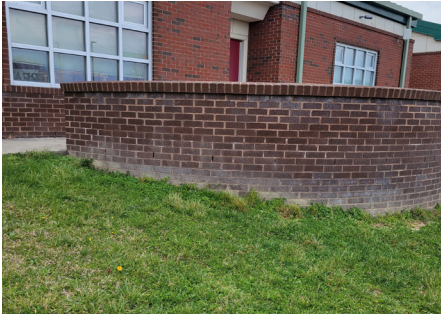
- A Some exterior finishes show discoloration and efflorescence (most non-cavity landscape walls)
- B Middle school boys' bathroom shows signs of abuse by students (toilet paper dispensers and urinal screens removed from wall; ceiling shows evidence of puncture by writing utensils)
- C Paint drippings on finishes and rubber base overrun in multiple locations
- D Paint chipped in multiple locations, both interior and exterior
- E Ceiling stained in multiple locations
- F Eastern corner bathroom lobby has several cracks in floor finish
- G Gutter damage and leakage in multiple locations

**01** Efflorescence has developed on several non-cavity masonry walls

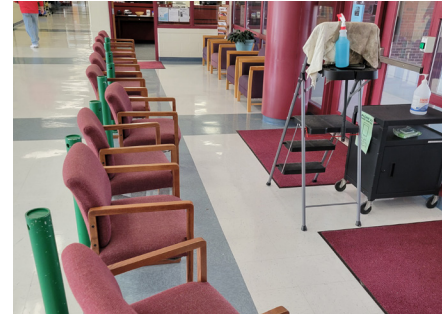
**03** No secure vestibule

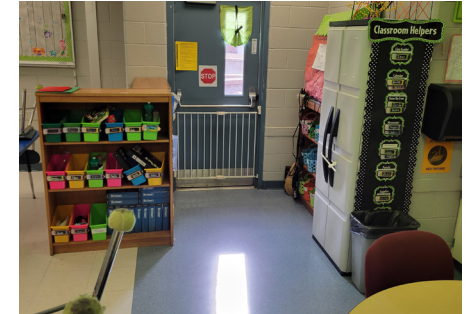
**04** Baby gate blocks egress route

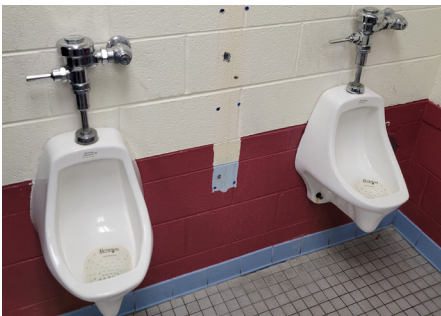
**05** No urinal screen (possible student removal)

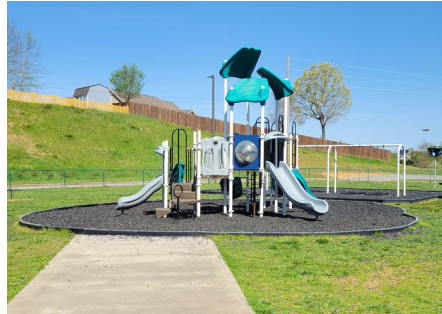
02

Playground is not ADA accessible; No ADA-compliant play equipment

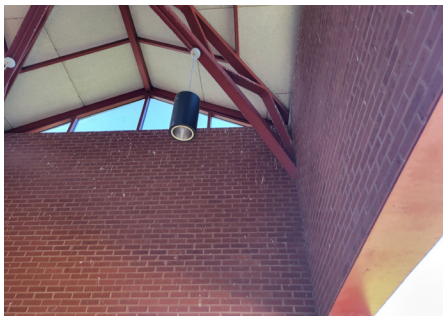
05

Birds roosting in exterior canopies and exterior locations

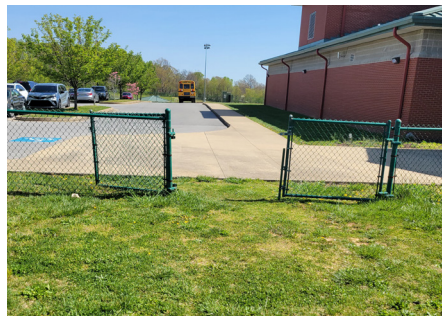
06

Perimeter fencing with open and unlocked gate at time of visit

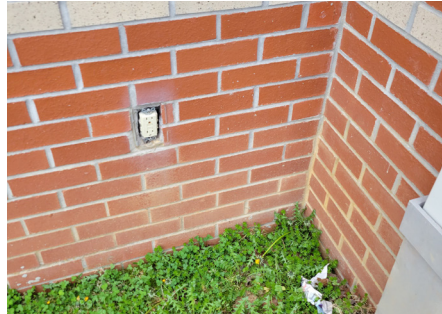
02 Some exterior receptacle covers are missing

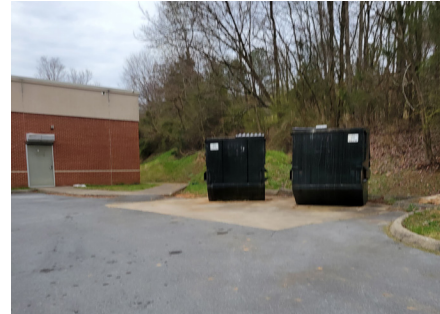
03 No dumpster enclosure

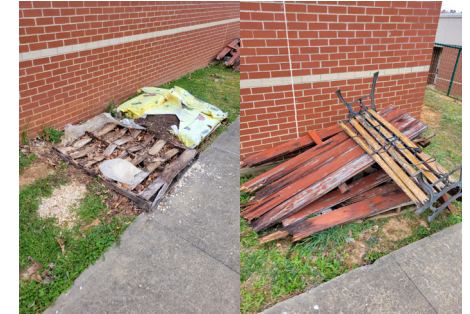
04 Rubbish around building at time of visit

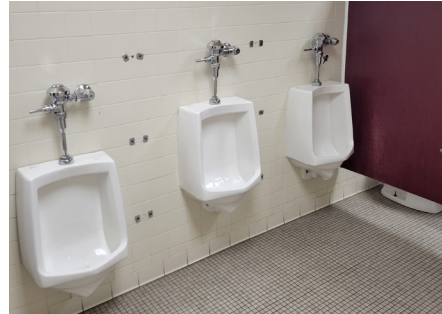
02

Urinal screens are not present (visible evidence of removal).

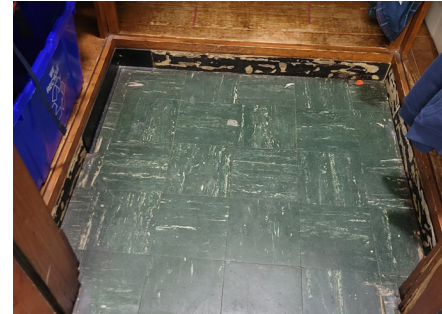
03

Evidence of possible hazardous material in classroom - would require further investigation by appropriate testing agency

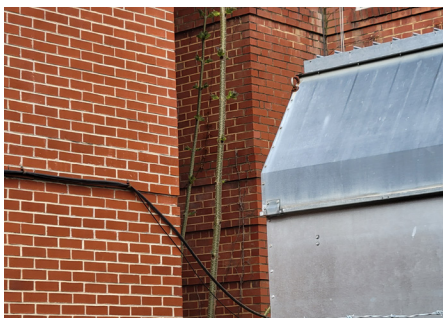
05

Tree growing behind the HVAC equipment

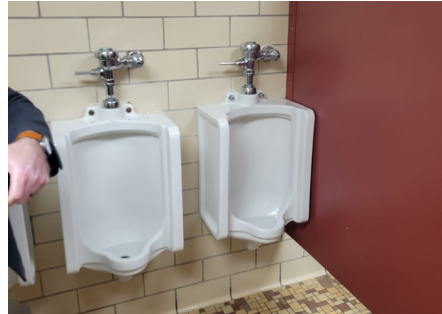
02 No urinal screens

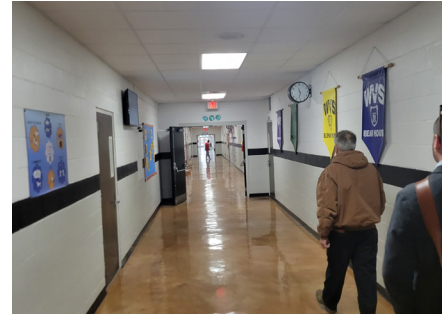
03 Long sight lines with few cameras - potential security risk

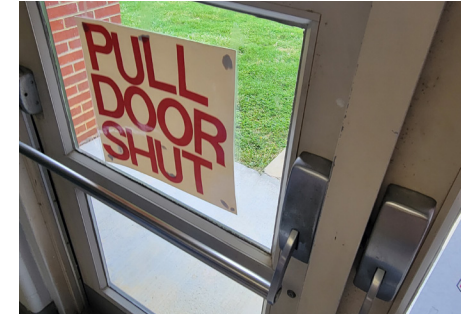
04 Egress door closures need to be adjusted so they close on their own

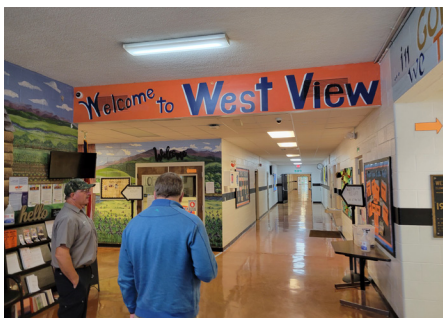
05 Open lobby provides access to entire school

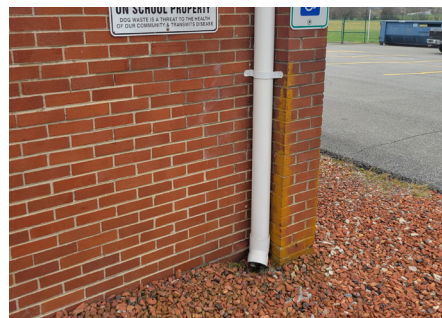
- A Staining on cafeteria ceiling
- B Some exterior finishes show discoloration and efflorescence
- C Gutter adjacent to western most exit damaged
- D Masonry corner guard at kitchen service entrance impacted - unknown if damaged underneath

06 Some discoloration on brick

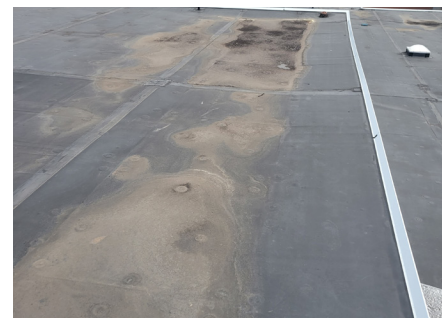
07 Roof shows signs of ponding

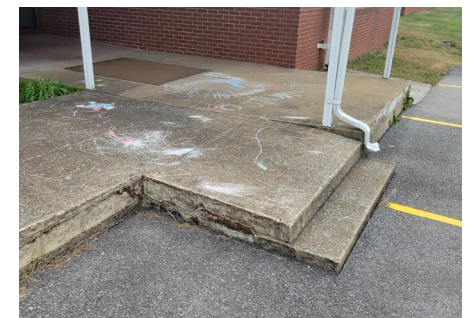
08 Some egress is not ADA compliant

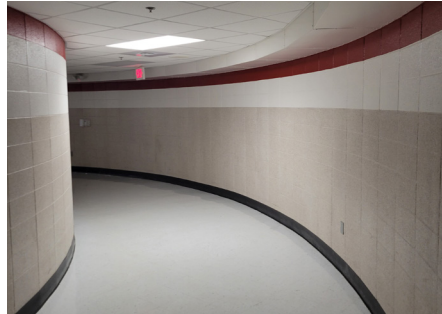
02

Sight lines in pod areas are short

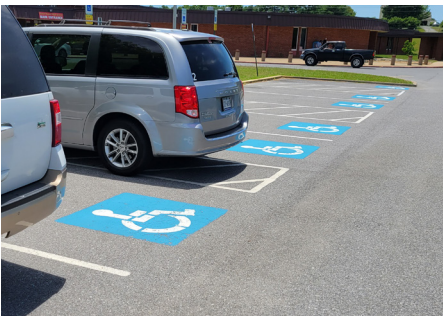
05

ADA parking near main entry

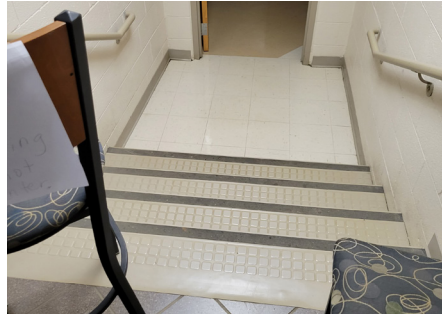
02 Guidance department accessible via rear entrance off G-Pod corridor.

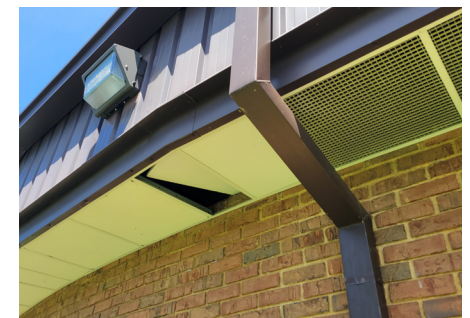
08 Soffit panels misaligned at several locations.

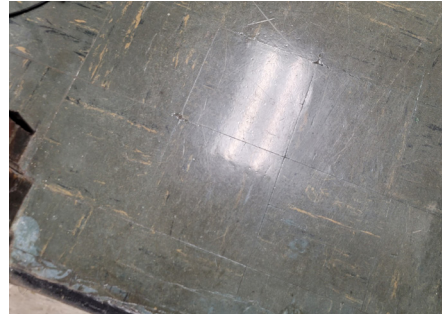
02 Former gym has evidence of possible hazardous material - would require further investigation by appropriate testing agency

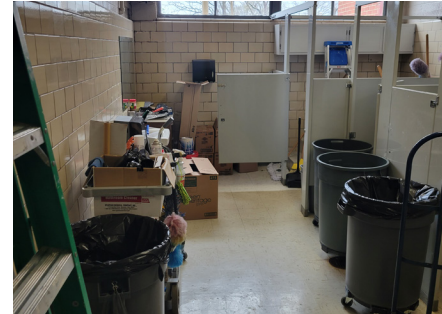
03 Elementary bathroom re-purposed into a janitor's closet

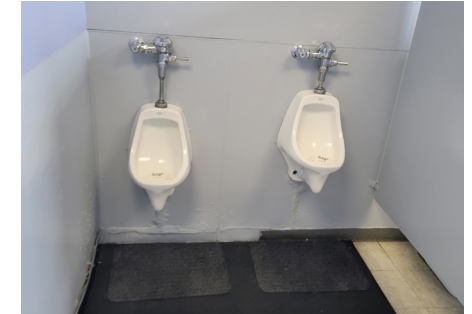
04 No urinal screens

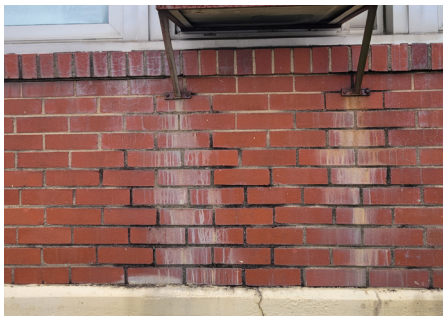
05 Brick is discolored

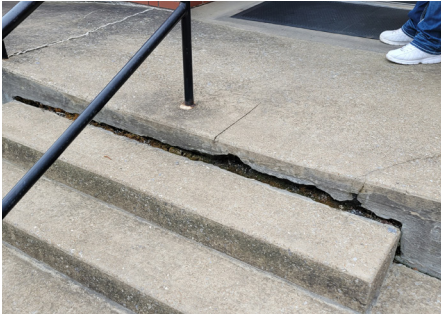
- A Discoloration in multiple locations
- B Brick is cracked in several locations - some have been patched
- C Concrete steps at main entry have severe to moderate damage
- D Rear shed has moderate cracking in block wall

**01** Main entry steps have moderate to severe damage and cracking

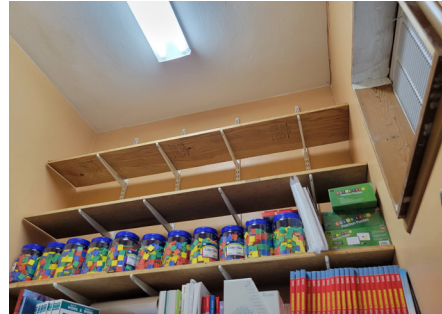
**02** Shelf storage above normal reaching ability

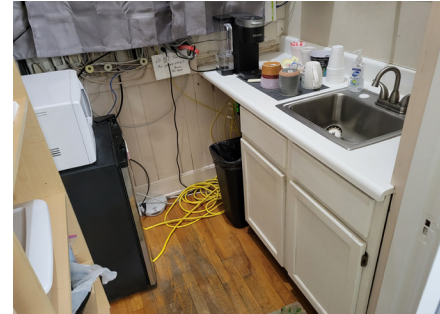
- A The make shift break room has a water supply and electrical equipment within close proximity
- B Steps in several locations do not have a code-compliant riser height
- C Stairwell to basement has low head height with no caution indicator
- D Asphalt near dumpster is severely damaged

**03** Break room is small, non-ADA compliant - electrical equipment creates potential hazard

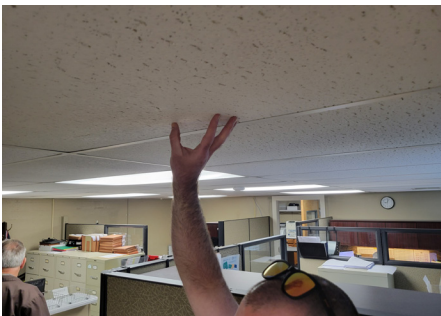
**05** Low head height in basement

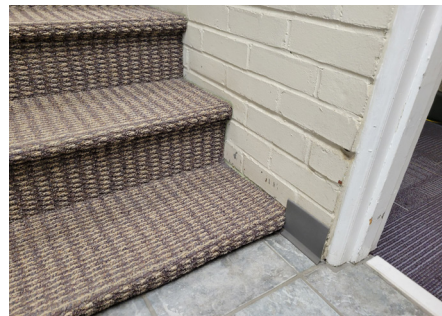
**06** Steps in several locations are not code compliant

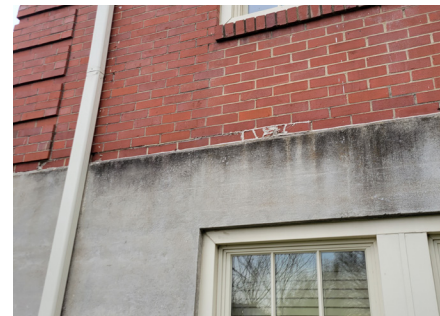
**07** Exterior brick concrete are discolored in multiple locations

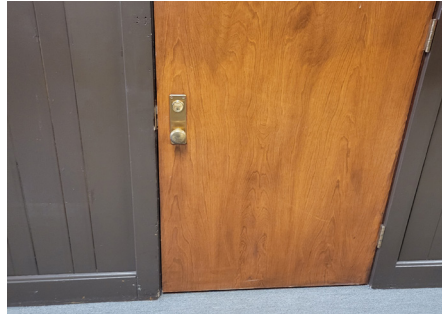
01

Main entry is not ADA compliant
